DEPARTMENT OF TRANSPORTATION

Contract #: 04-0120F4Cty: SF/ALA Rte: 80 PM: 13.2/13.9File #: 69.28**WELDING INSPECTION REPORT****Resident Engineer:**Siegenthaler, Peter**Address:** 333 Burma Road**City:** Oakland, CA 94607**Report No:** WIR-017999**Date Inspected:** 03-Nov-2010**Project Name:** SAS Superstructure**OSM Arrival Time:** 700**Prime Contractor:** American Bridge/Fluor Enterprises, a JV**OSM Departure Time:** 1900**Contractor:** Zhenhua Port Machinery Company, Ltd (ZPMC), Changxing Island **Location:** Shanghai, China**CWI Name:** Mr. Li jia**CWI Present:** Yes No**Inspected CWI report:** Yes No N/A**Rod Oven in Use:** Yes No N/A**Electrode to specification:** Yes No N/A**Weld Procedures Followed:** Yes No N/A**Qualified Welders:** Yes No N/A**Verified Joint Fit-up:** Yes No N/A**Approved Drawings:** Yes No N/A**Approved WPS:** Yes No N/A**Delayed / Cancelled:** Yes No N/A**Bridge No:** 34-0006**Component:** Orthotropic Box Girder(OBG)**Summary of Items Observed:**

WELDING INSPECTION REPORT

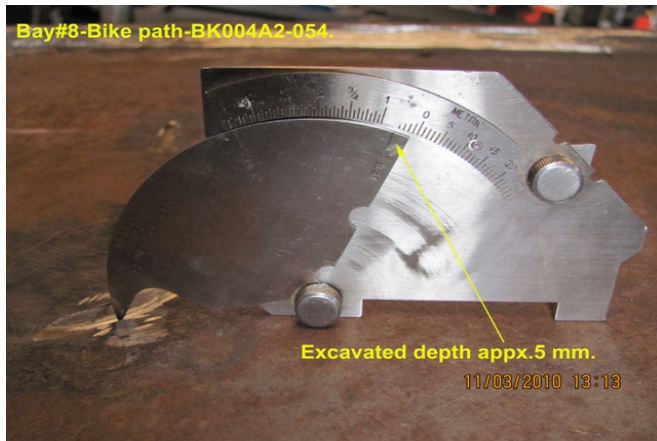
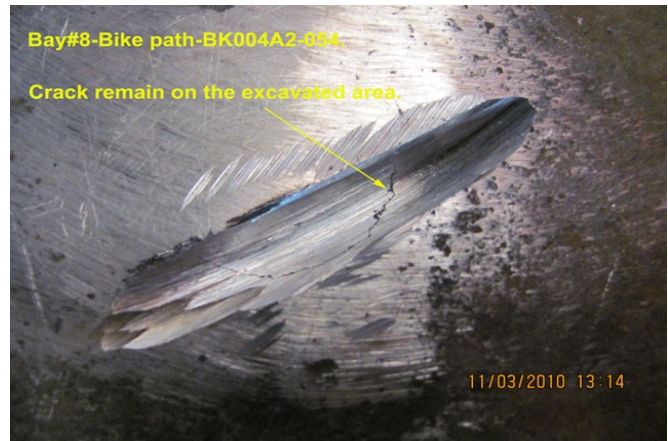
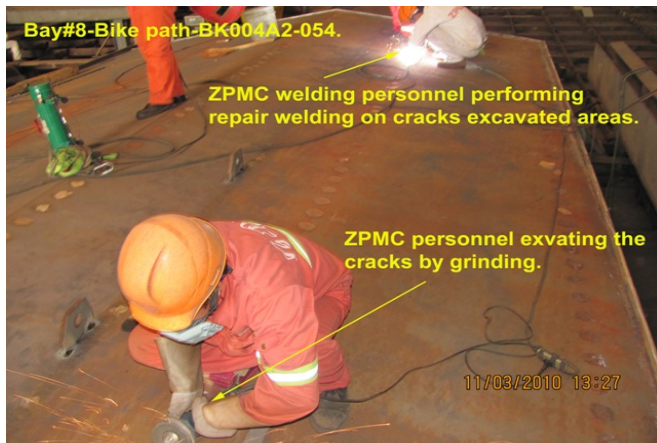
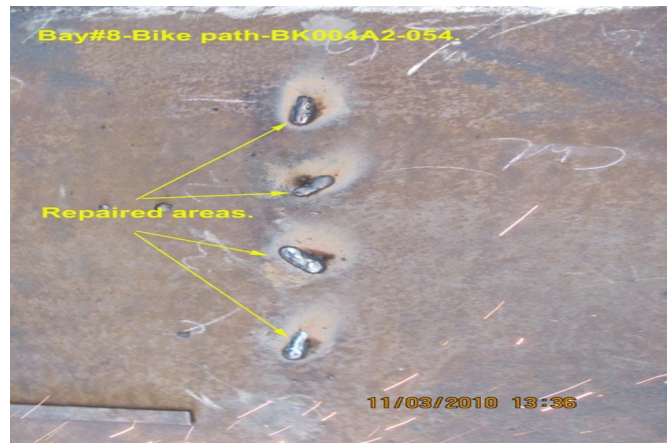
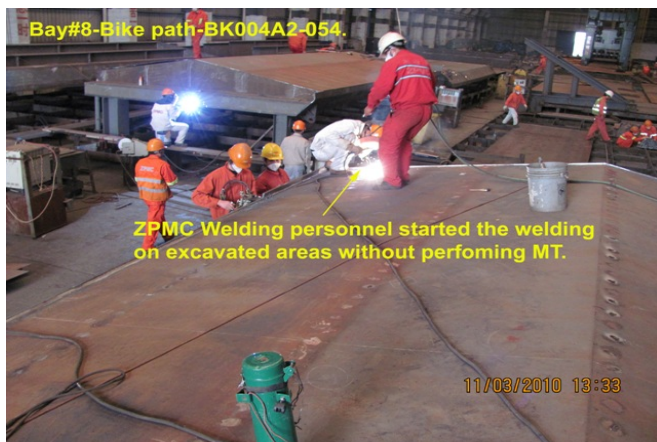
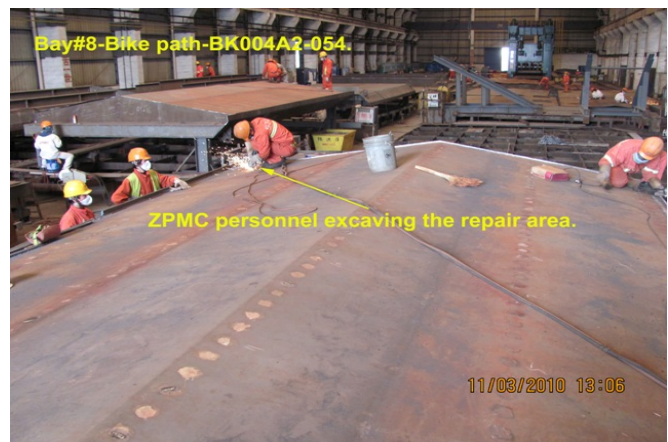
During the QA random visual inspection of the Bike path bottom plate of BK004A2-054, this QA Inspector observed ZPMC welding personnel were performing weld repair on the excavated cracked plug welds areas not according to the approved Critical Welding Repair (CWR) report No.B-CWR-2102. The approved CWR 2102 specifies that before welding, the excavated areas shall be verified with Visual Testing (VT) and MT to ensure that they are free of defect. The excavation depth is approximately 5 mm in depth. ZPMC personnel did not verify the excavated area by MT prior to welding. QA noted that the excavated area has a crack and reminded ZPMC that MT shall be performed prior to weld repair. The weld with the VT crack is BK004A2-054-020 (3rd hole from BKPL6B).ZPMC proceeded with welding without MT. The Bike path number is identified as BK004A2-054.The welds are identified as BK004A2-054-014,015,017,019,020.The thickness of the bottom plate is 6 mm.

This QA generated an incident report on this date for the above issue, for further information see the incident report and attached photos.
